TAYLOR COLLIERY REDEVELOPMENT PROJECT

**Presented by:
Gregory M. Firely
Malcolm Pirnie, Inc.**

July 14, 2009

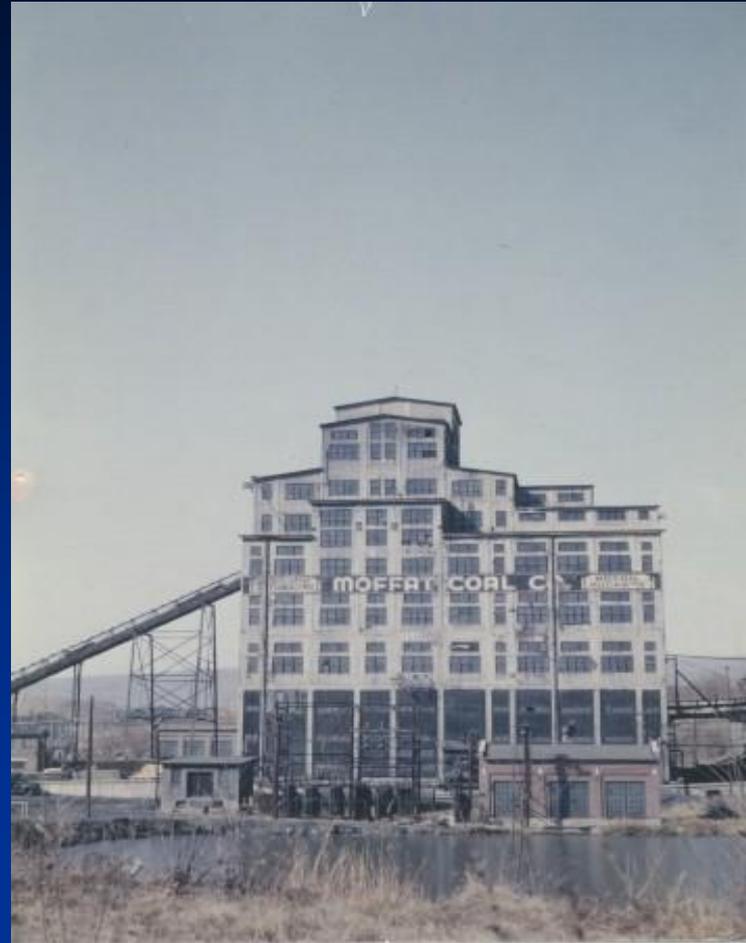
About 5000 cubic yards of concrete, 500 tons of rebar, and 500,000 feet of lumber were used in the construction. When completed the structure stood 107 feet wide, 133 feet long, and 167 feet high, dominating the Taylor skyline.

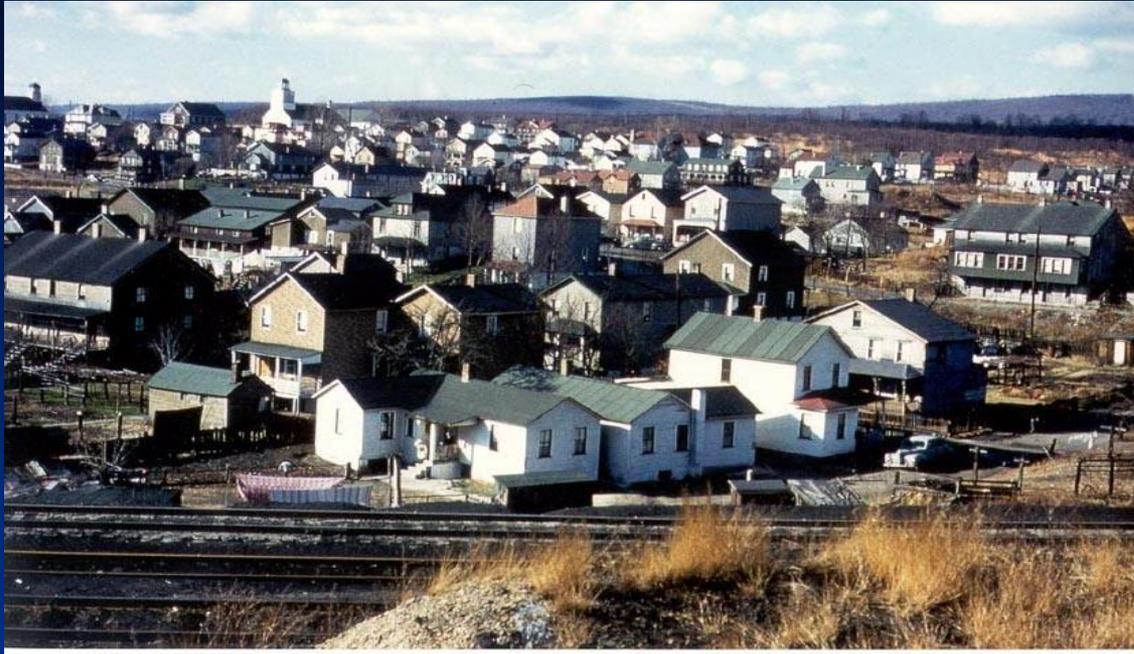
Coal Mining Issues on the Town, subsidence

- The Feltsville Patch swath of land adjacent to and above coal mining operations.
- Subsidence issues led to the condemnation of this 58 acre area of Taylor
- A total of nine coal seams exist below all or portions of the fifty-eight (58) acre area.

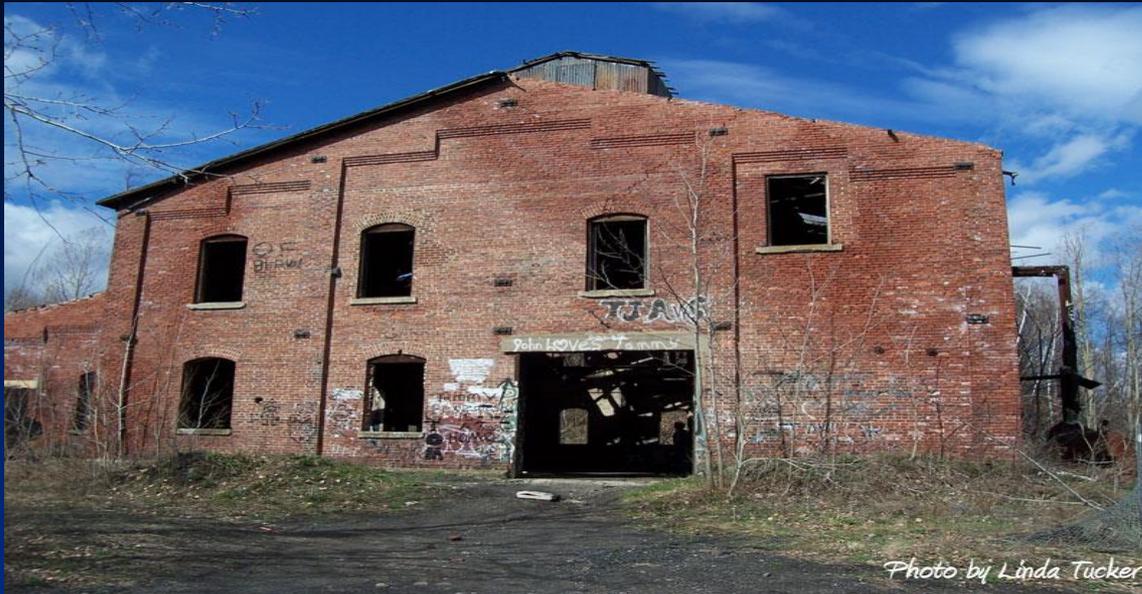
Boiler Building

- The existing structure is a one story structure in a truncated “T” configuration.
- Main portion is approximately 80’ x 60’
- Brick wall are approximately 12” thick
- Main portion is high enough to support two stories with a steel truss roof system

- Overall proportions and scale
- Articulated brickwork on exterior
- The heads of the panels are corbelled uniformly
- Graceful arched windows

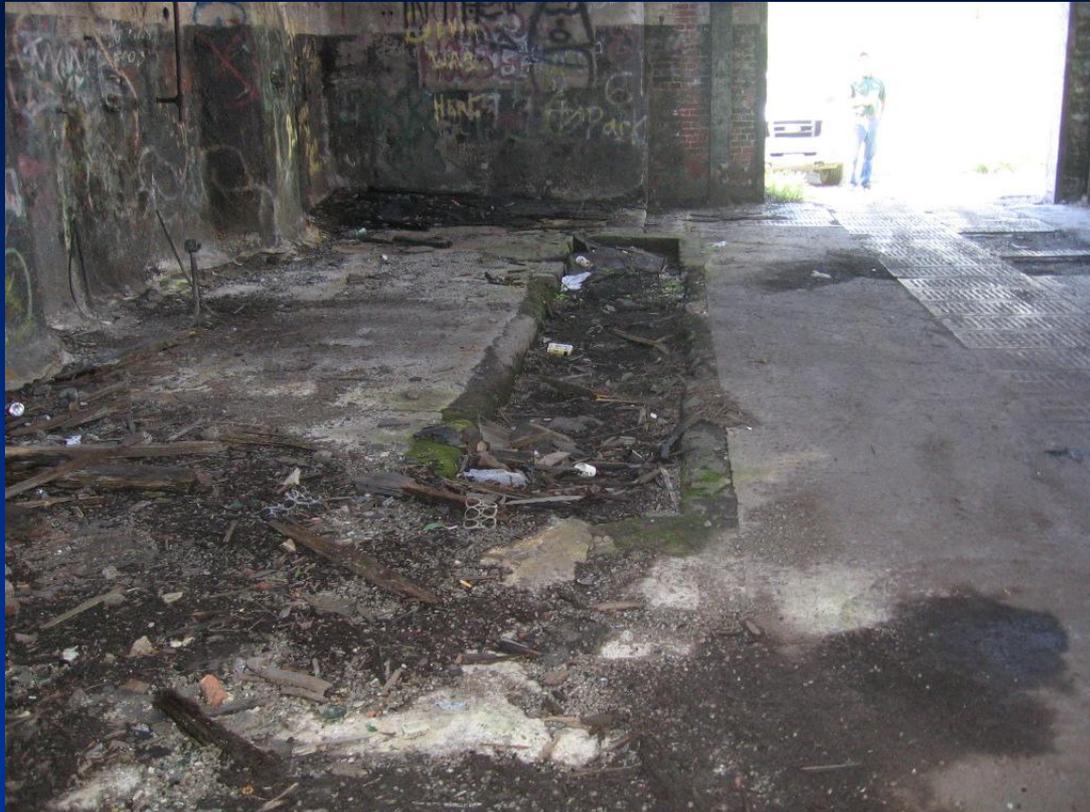
Boiler Building Assessment, Phase I

- During the site reconnaissance, heavy petroleum staining was observed on the floor of the “boiler” building, the roof has collapsed in several areas and the structure may flood during rain events, potentially resulting in contaminated run off.
- During the site reconnaissance pits with apparent dirt bottoms were identified in the “boiler” building. As well as grates with unknown bottoms. It is unclear if these were utilized as floor drains.

- Based on the isolated nature of these exceedances, the most effective way to obtain an Act 2 closure with would be through removal of the soil in the floor drains.
- Additionally samples also exceeded the non-residential SHS for the soil-to-groundwater pathway. Recent promulgation of the Pennsylvania Uniform Environmental Covenants Act (UECA) closure under the non-residential MSCs would likely result in PADEP requiring deed restriction and possibly maintenance of engineering controls to eliminate potential exposure pathways for the detected RCRA metals in soil on-Site.
- The ACM will need to be removed.

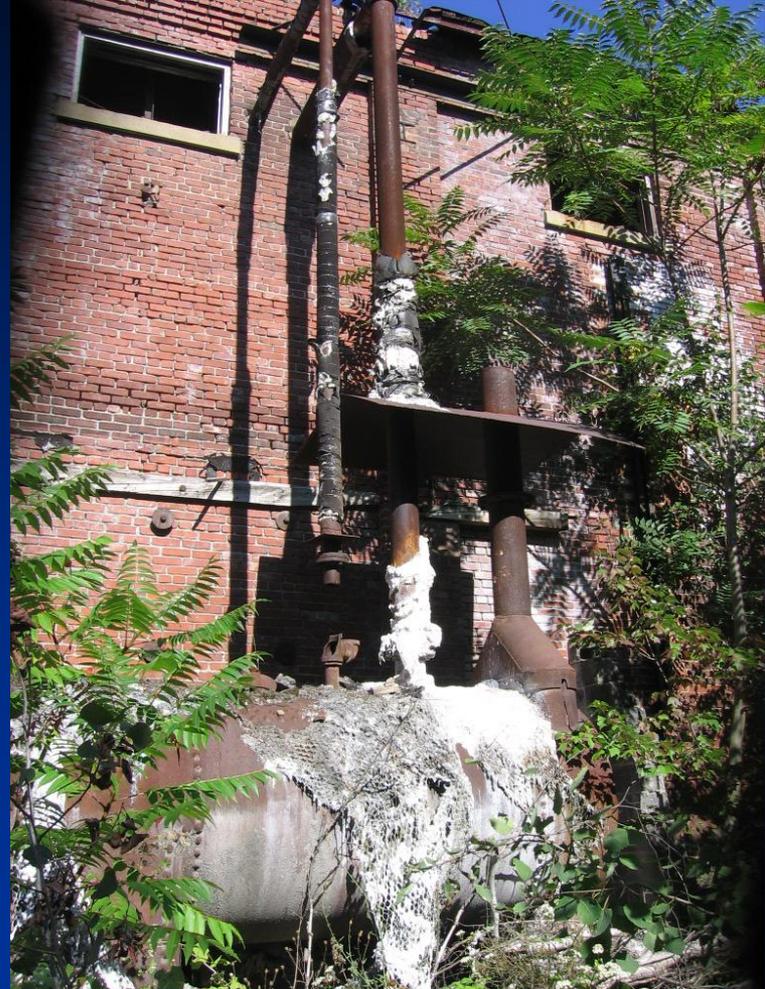
Boiler Building Assessment, Phase I

- During the site reconnaissance an Asbestos Survey was conducted. Asbestos Containing Material's were identified.

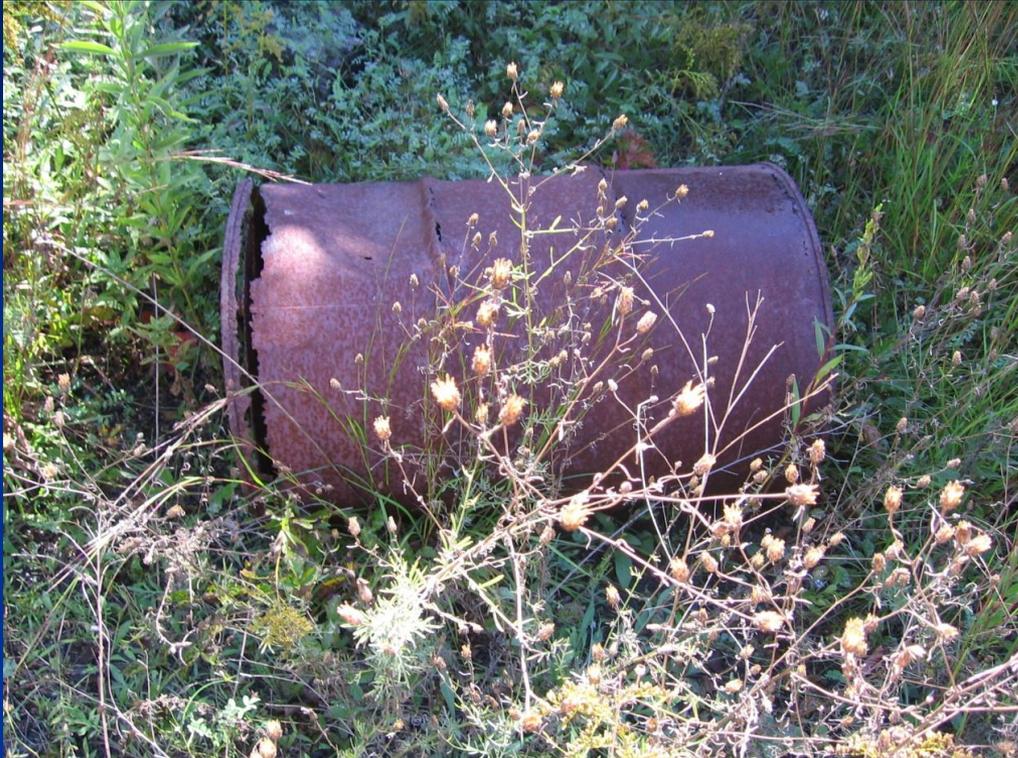
Boiler Building Assessment, Phase I

During the site reconnaissance, various drums were found about the site the structure and their contents could not be determined due to lack of labeling. The drums appeared to be empty and were heavily corroded.

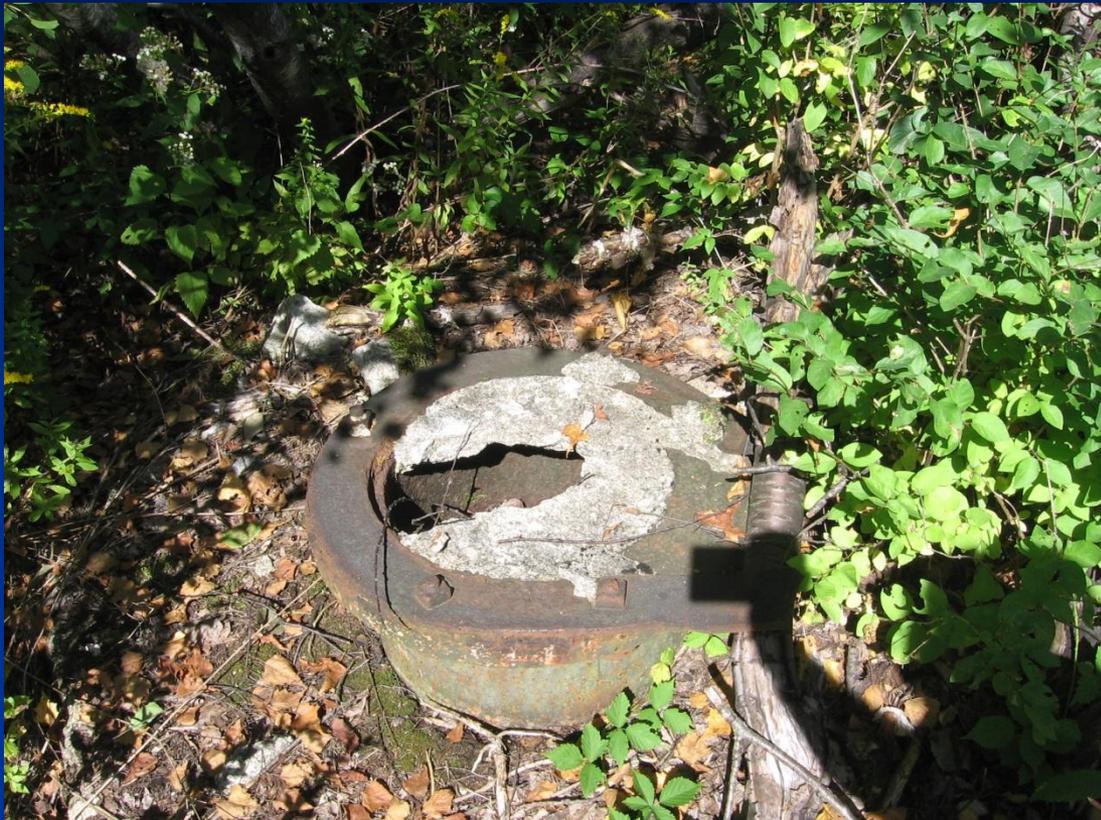
Boiler Building Assessment, Phase I

- During the site reconnaissance what appeared to be a possible man-way to an underground storage tank, possibly a rail tanker was noted.

- A total of 20 soil samples were collected at the Site as part of the Phase II investigation. No samples were collected from the potential UST because no UST was identified. All samples were analyzed for VOCs, SVOCs, RCRA metals, and PCBs with the exception of the samples from the electrical transformers which were analyzed for PCBs only.

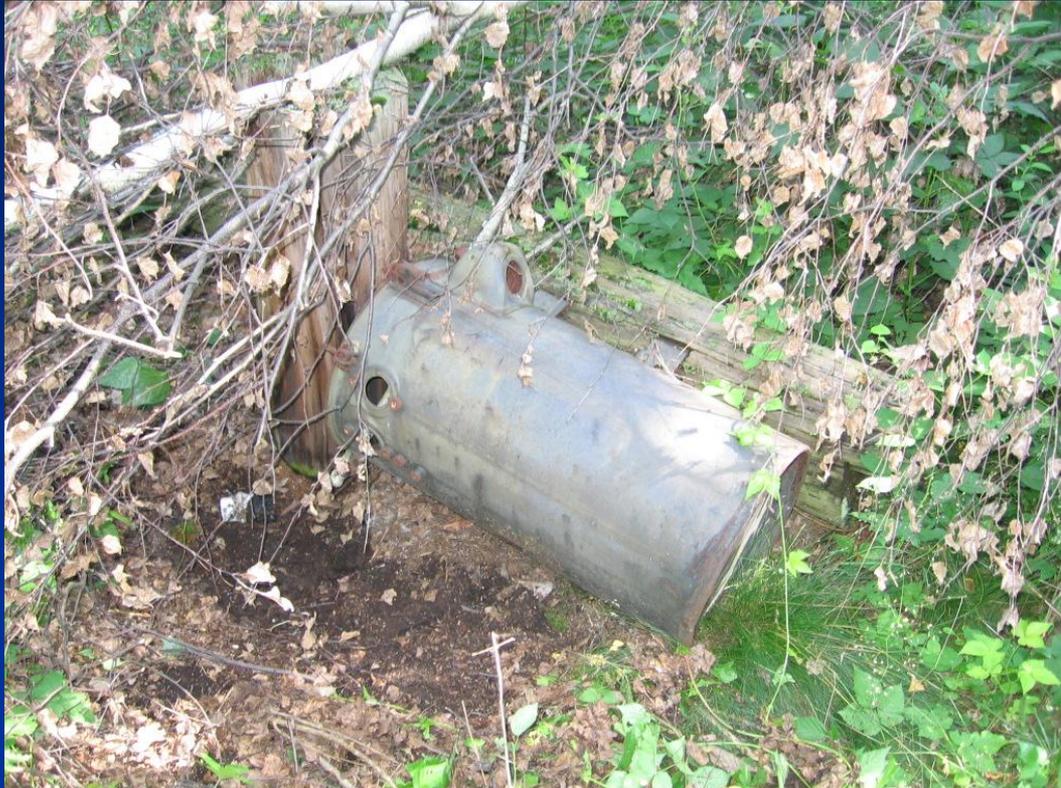
Boiler Building Assessment, Phase I

- A Previous Phase I identified electrical transformers on the ground, which are known to potentially contain polychlorinated biphenyl's (PCBs).

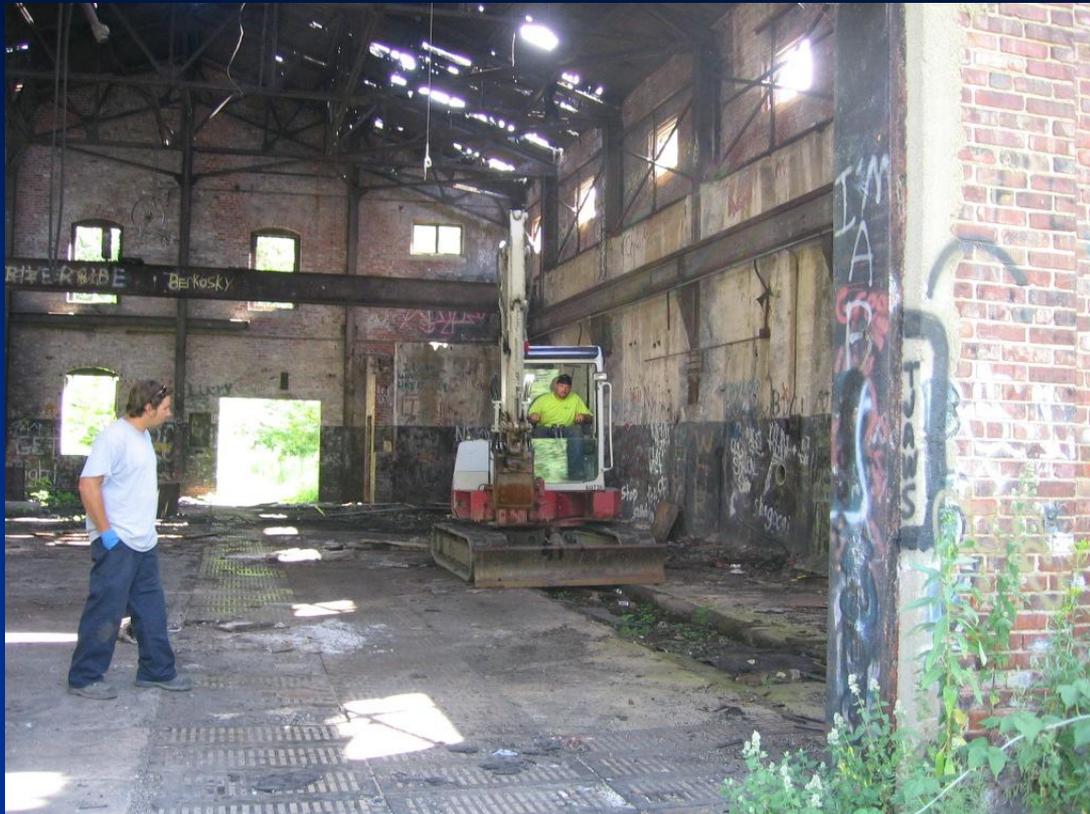
Boiler Building Assessment, Phase II

- No VOCs or PCBs above the State Health Standards (SHS)
- SVOCs were detected in the floor drains above the SHS; and
- RCRA metals were identified above the SHS, in the floor drains and below the building.

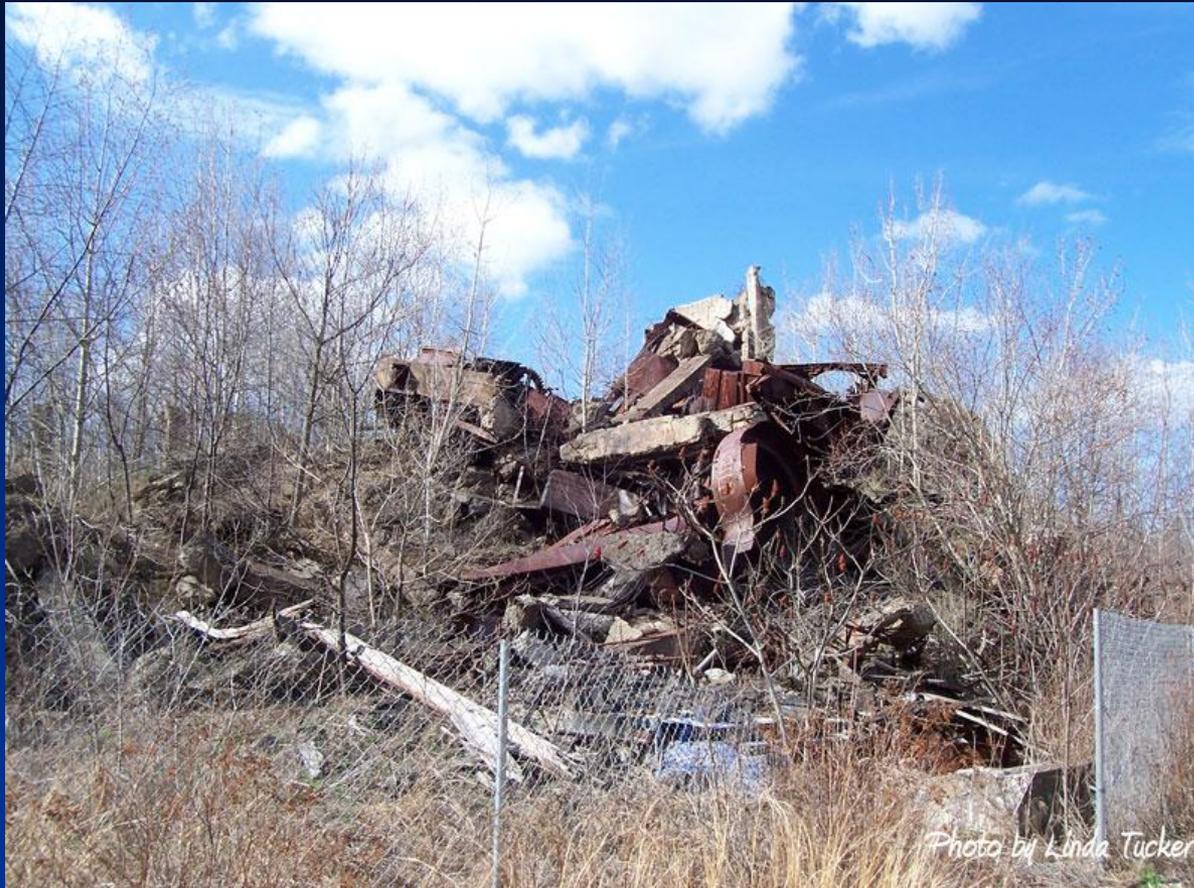
The Breaker Debris Pile

The Bureau of Abandoned Mine Reclamation has identified four old mining features which must be mitigated for the ultimate reclamation of this land.

BAMR awarded a \$1.4 million contract for the regrading of the piles of soil and restoration of Keyser Creek.

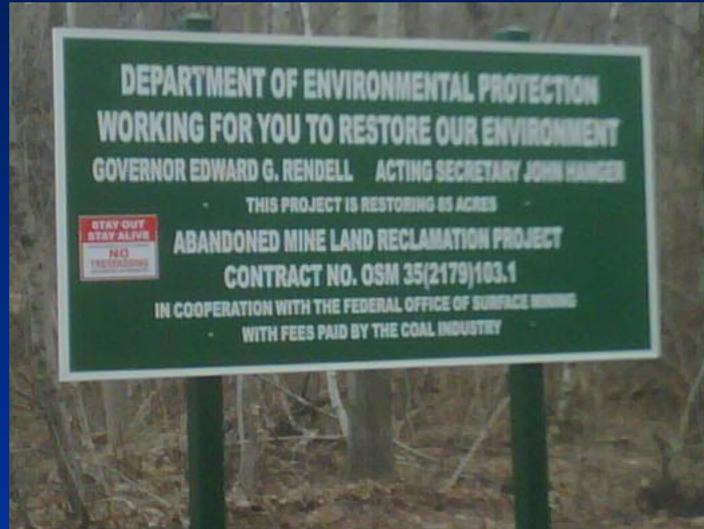
Taylor Borough kicked off the earth moving portion of the Taylor Colliery Redevelopment Plan on June 5 2009.

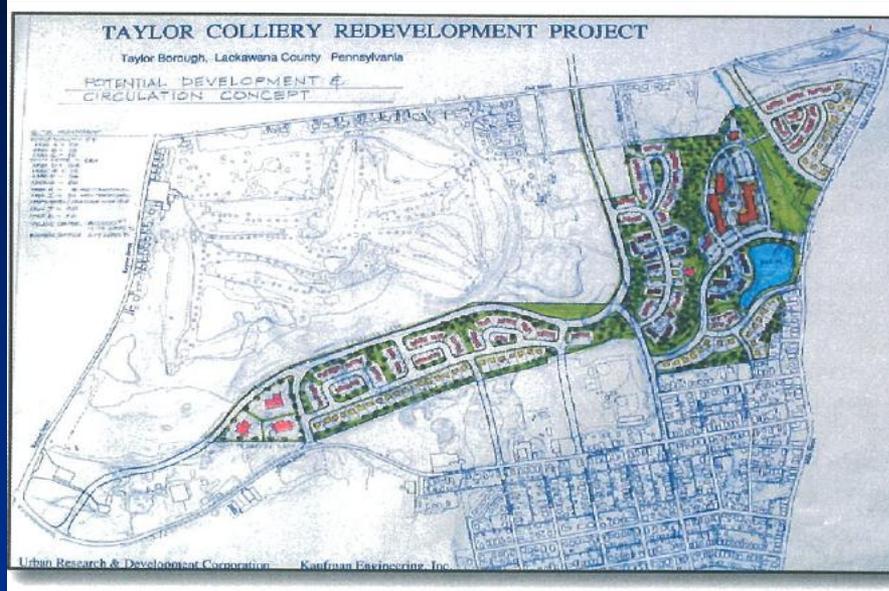
Concept One

Estimated Redevelopment:

± 54 Single Family Home Sites

± 224 Town Homes

± 116 Condominiums

New Village Center
± 80,000 S.F.

± 111,100 S.F. Of
Business Park

± 48 Acres Of Open
Space

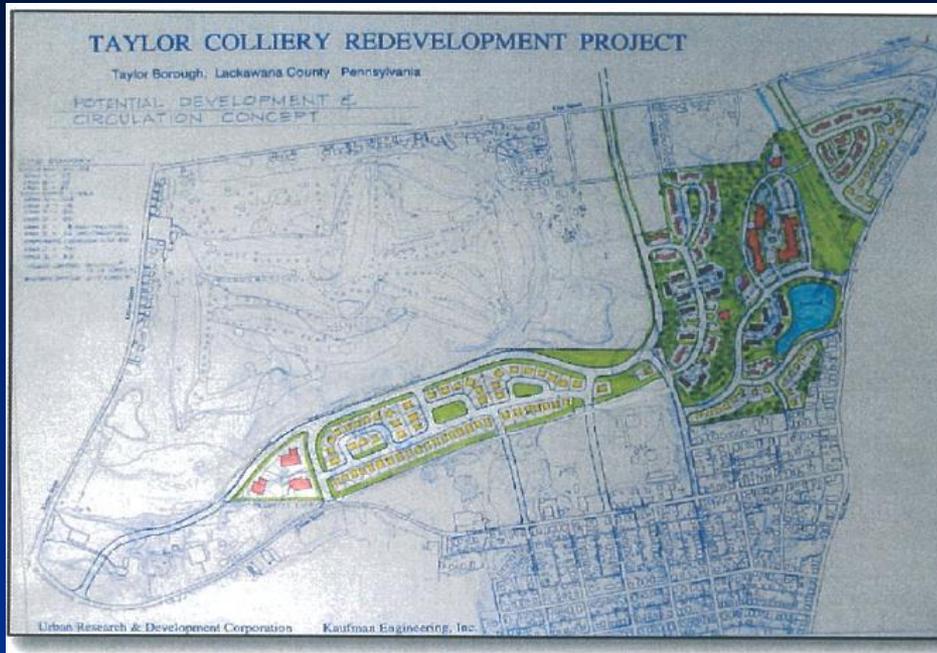
Concept Two

Estimated Redevelopment:

- ± 88 Single Family Home Sites
- ± 120 Town Homes
- ± 116 Condominiums
- New Village Center
± 80,000 S.F.
- ± 111,100 S.F. Of Business Park
- ± 48 Acres Of Open Space
