2009 PA Conference on Abandoned Mine Reclamation and Coal Mine Heritage

Restoration of the Paint Creek Watershed: Results of a Three Year Study

Paint Creek Watershed

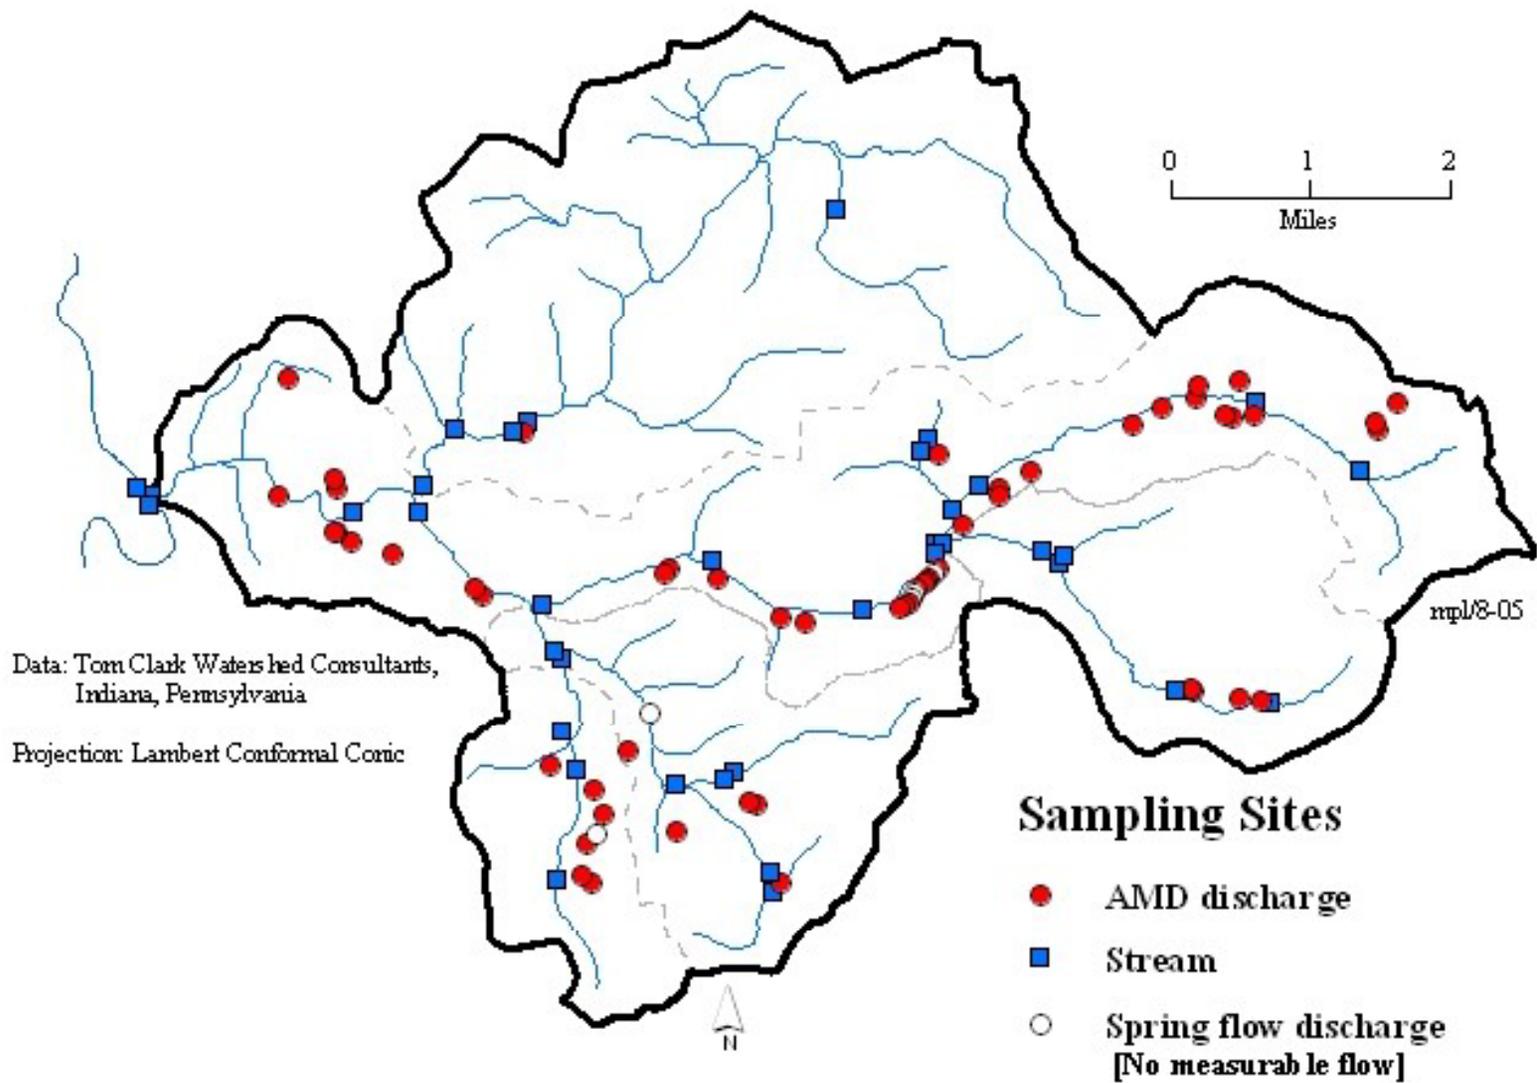
Figure 2. Data Collection Locations, Paint Creek Watershed Study, 2003-2005.

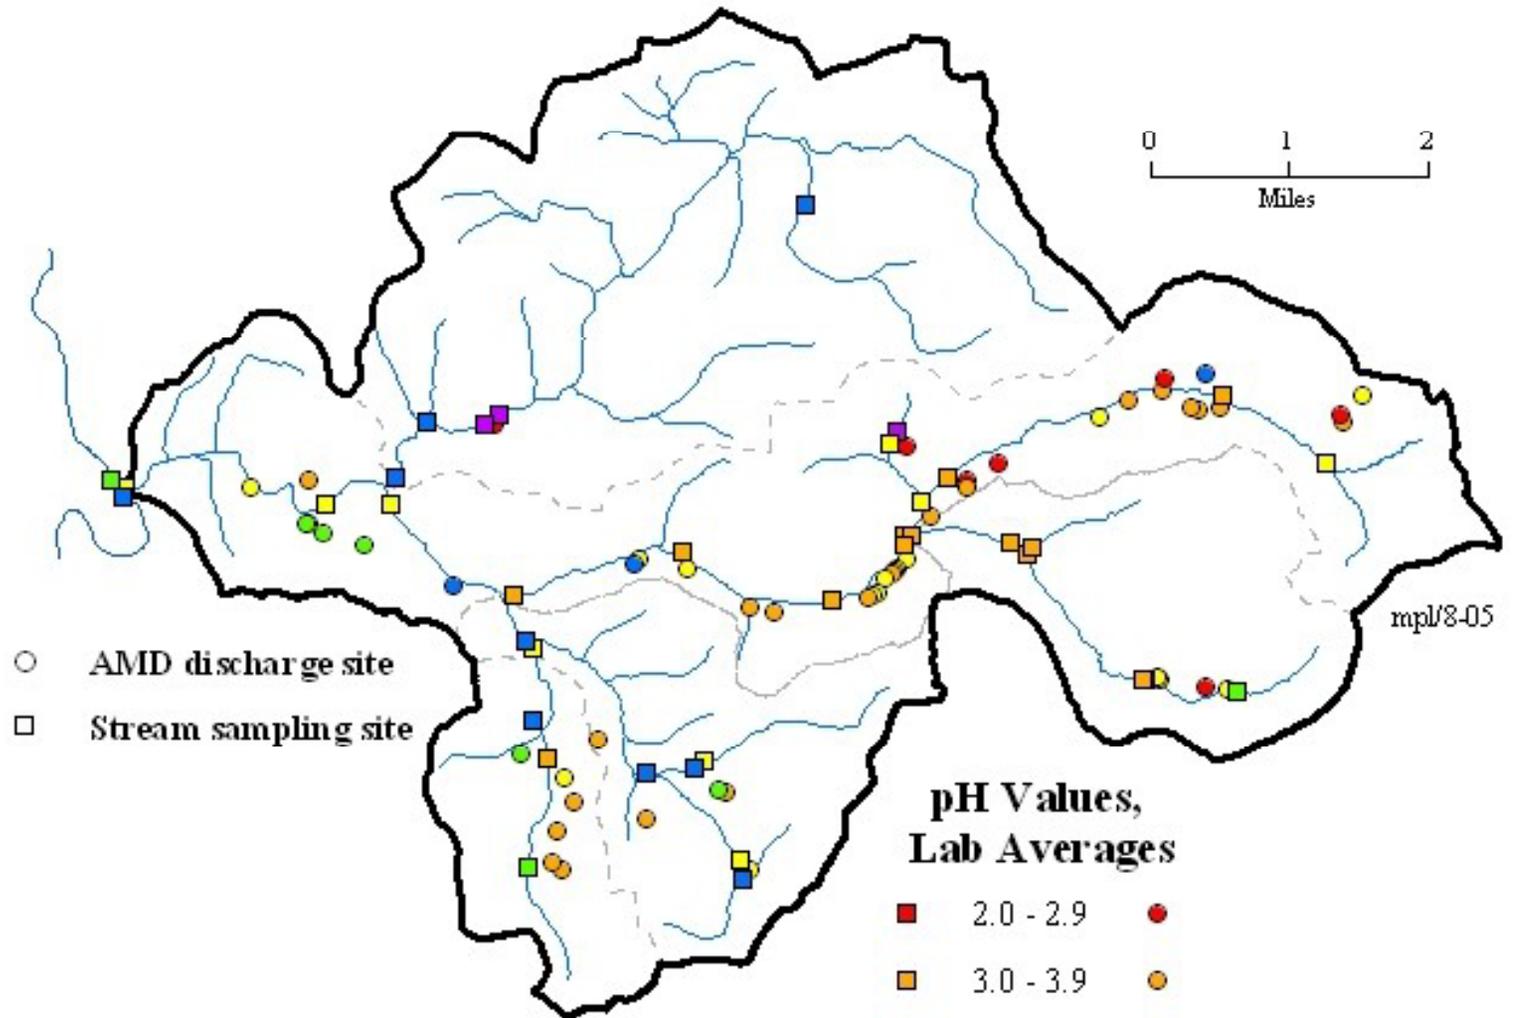
Figure 3. Lab pH values based on averages. Paint Creek is substantially impacted upstream of Seese Run and improves gradually downstream. Paint Creek also substantially impacts the Stonycreek River.

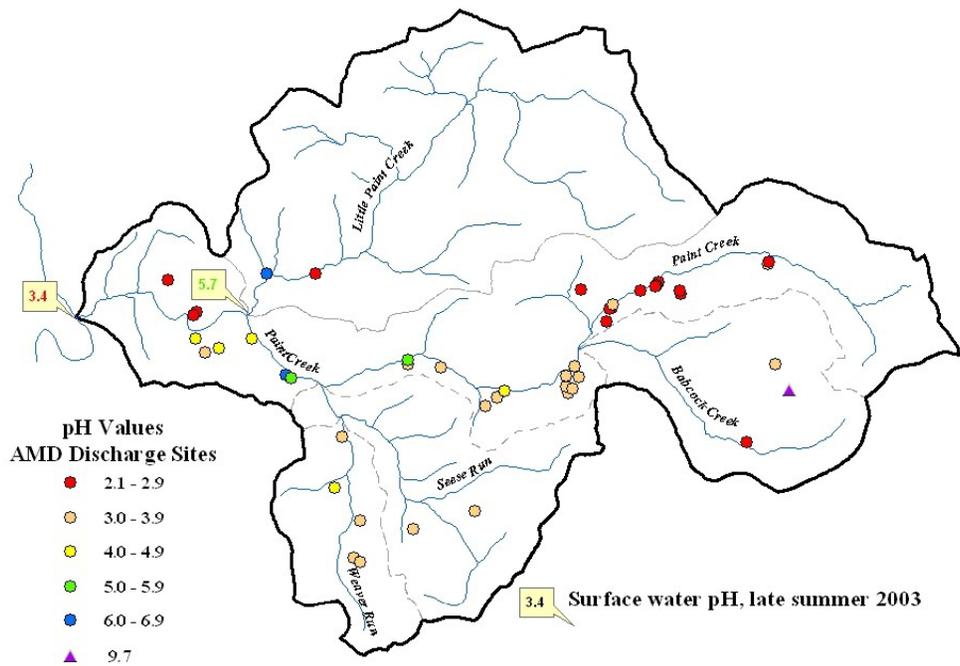
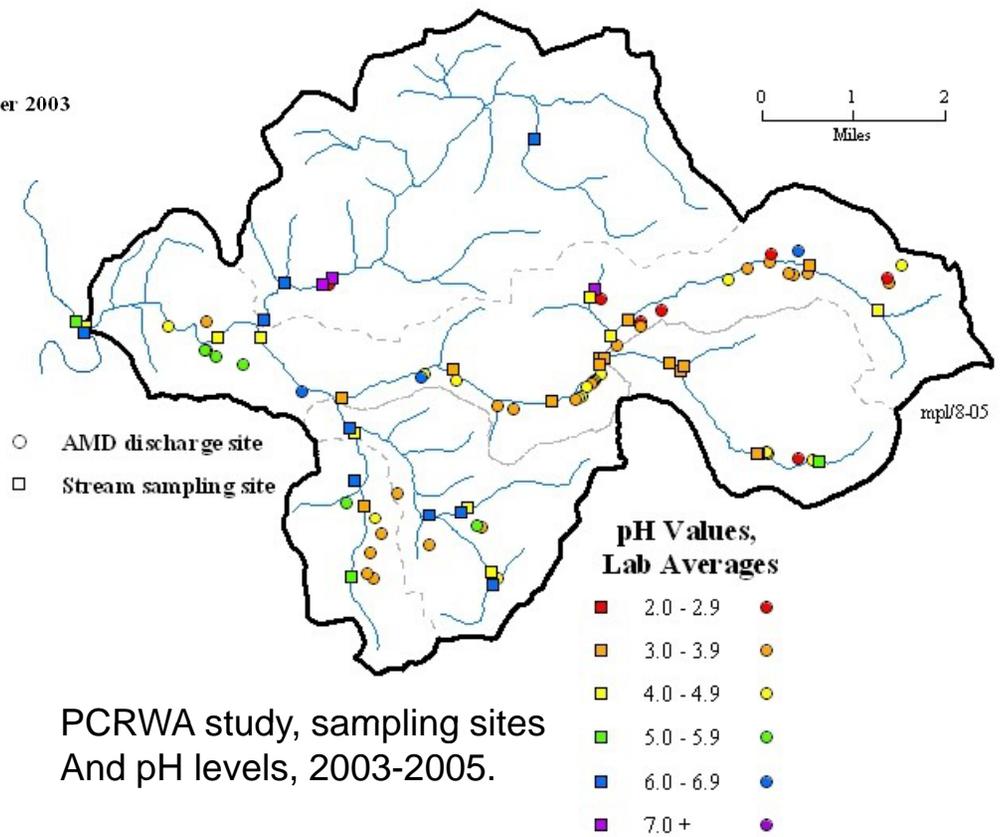
USGS sampling sites and pH levels, early 1990s.

PCRWA study, sampling sites
And pH levels, 2003-2005.

Figure 4. Some improvement in pH levels have occurred over the past decade, due to a combination of modest treatment efforts and mother nature.

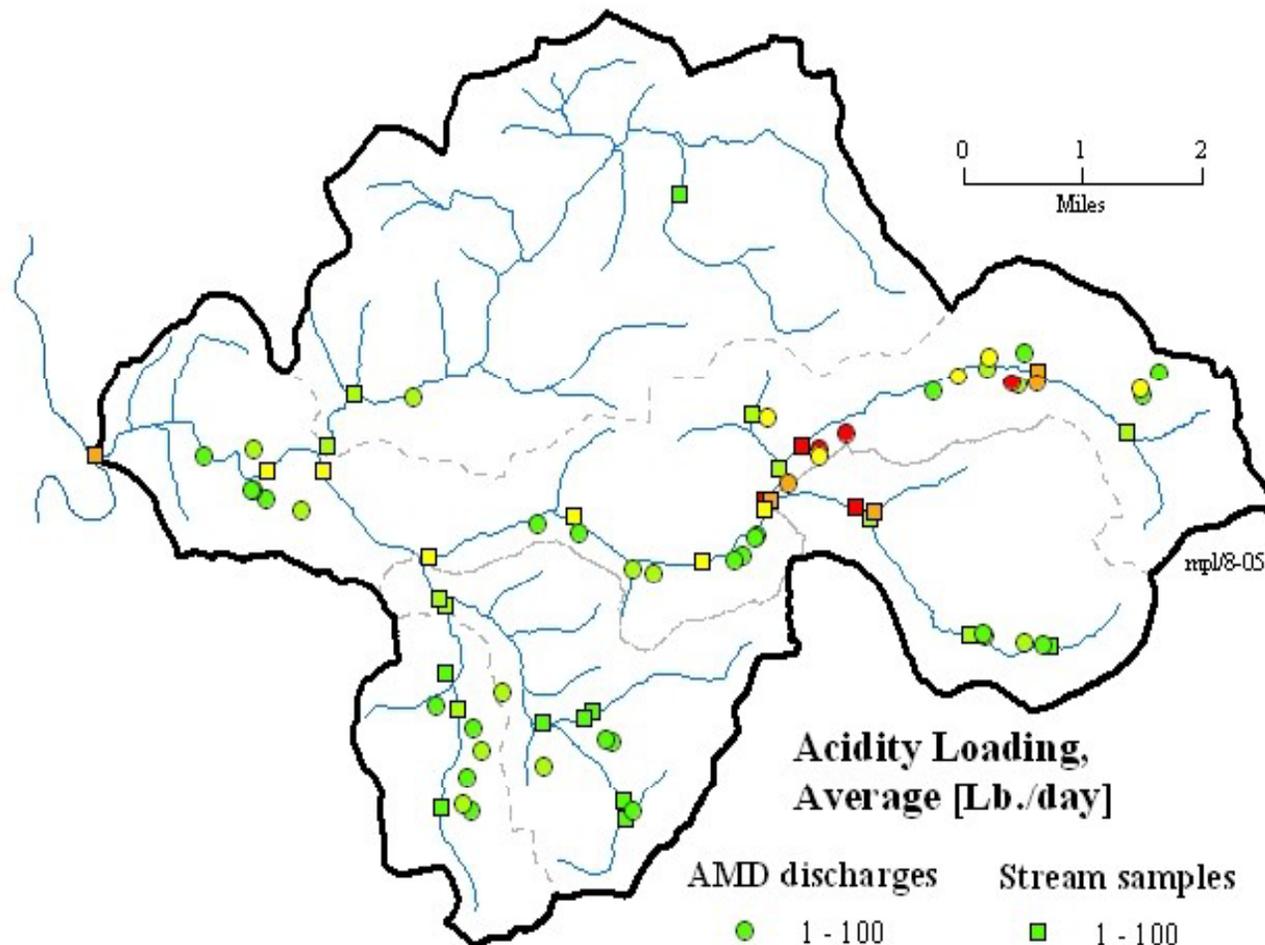
Figure 5. Total acidity loadings based upon lab averages. Acidity loadings are very high above Babcock Creek and slightly decline and hold steady thereafter.

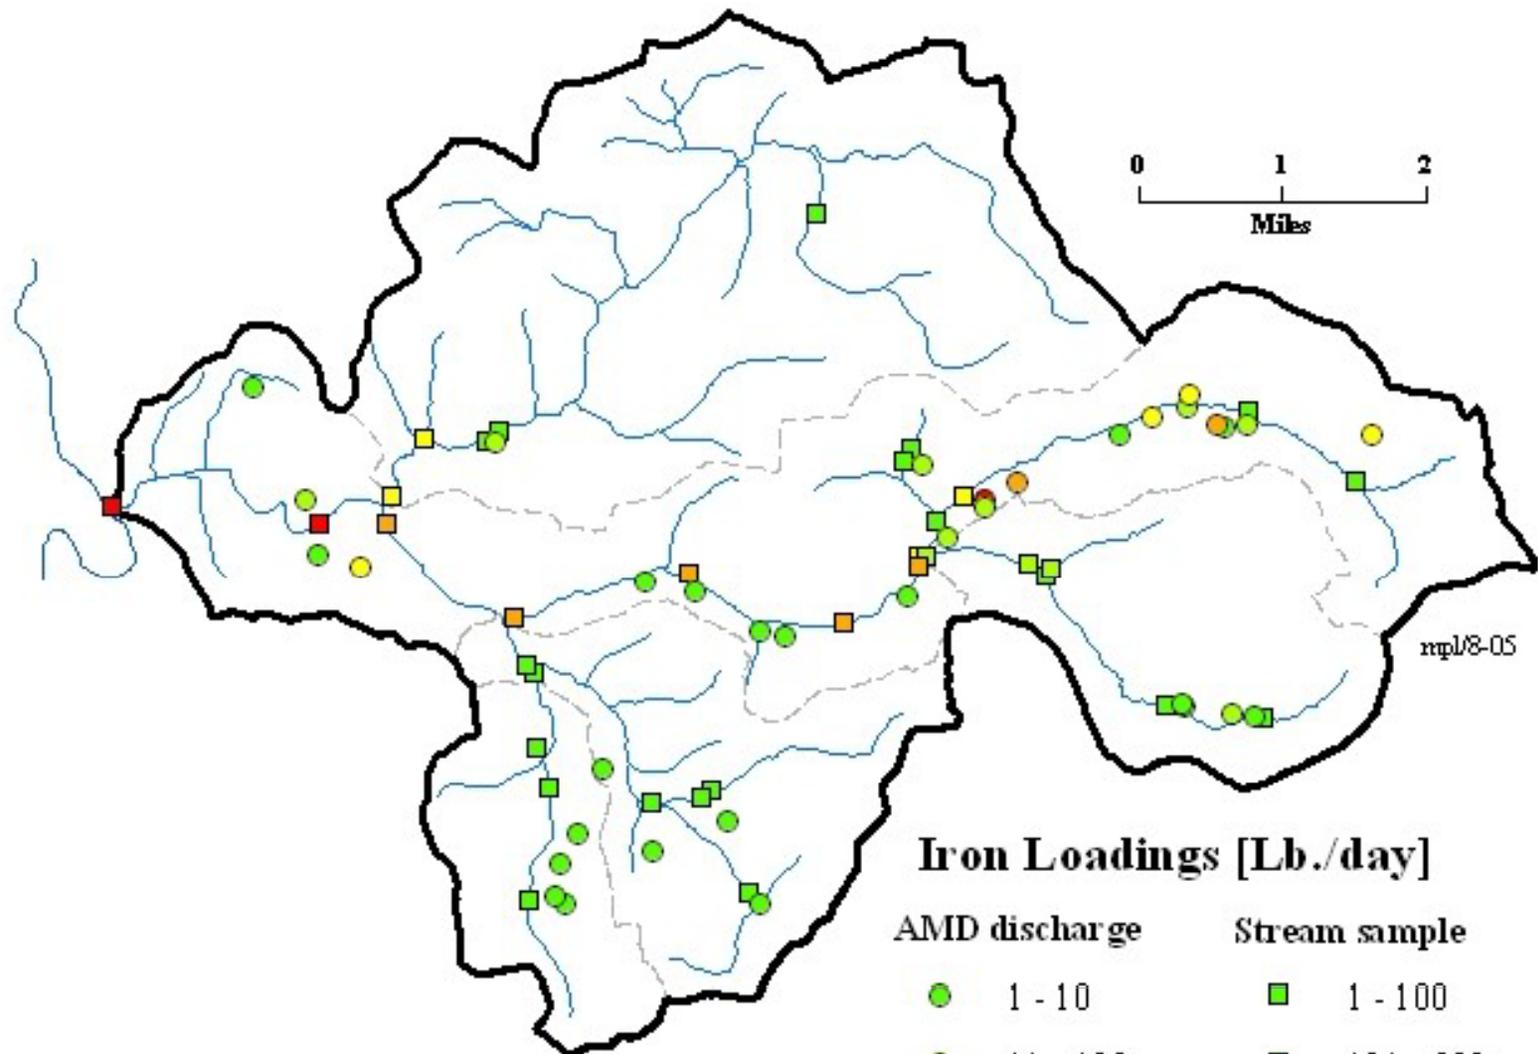
Figure 6. Cumulative effect of numerous AMD discharges is evident in the high iron concentrations on Paint Creek and lower Little Paint Creek.

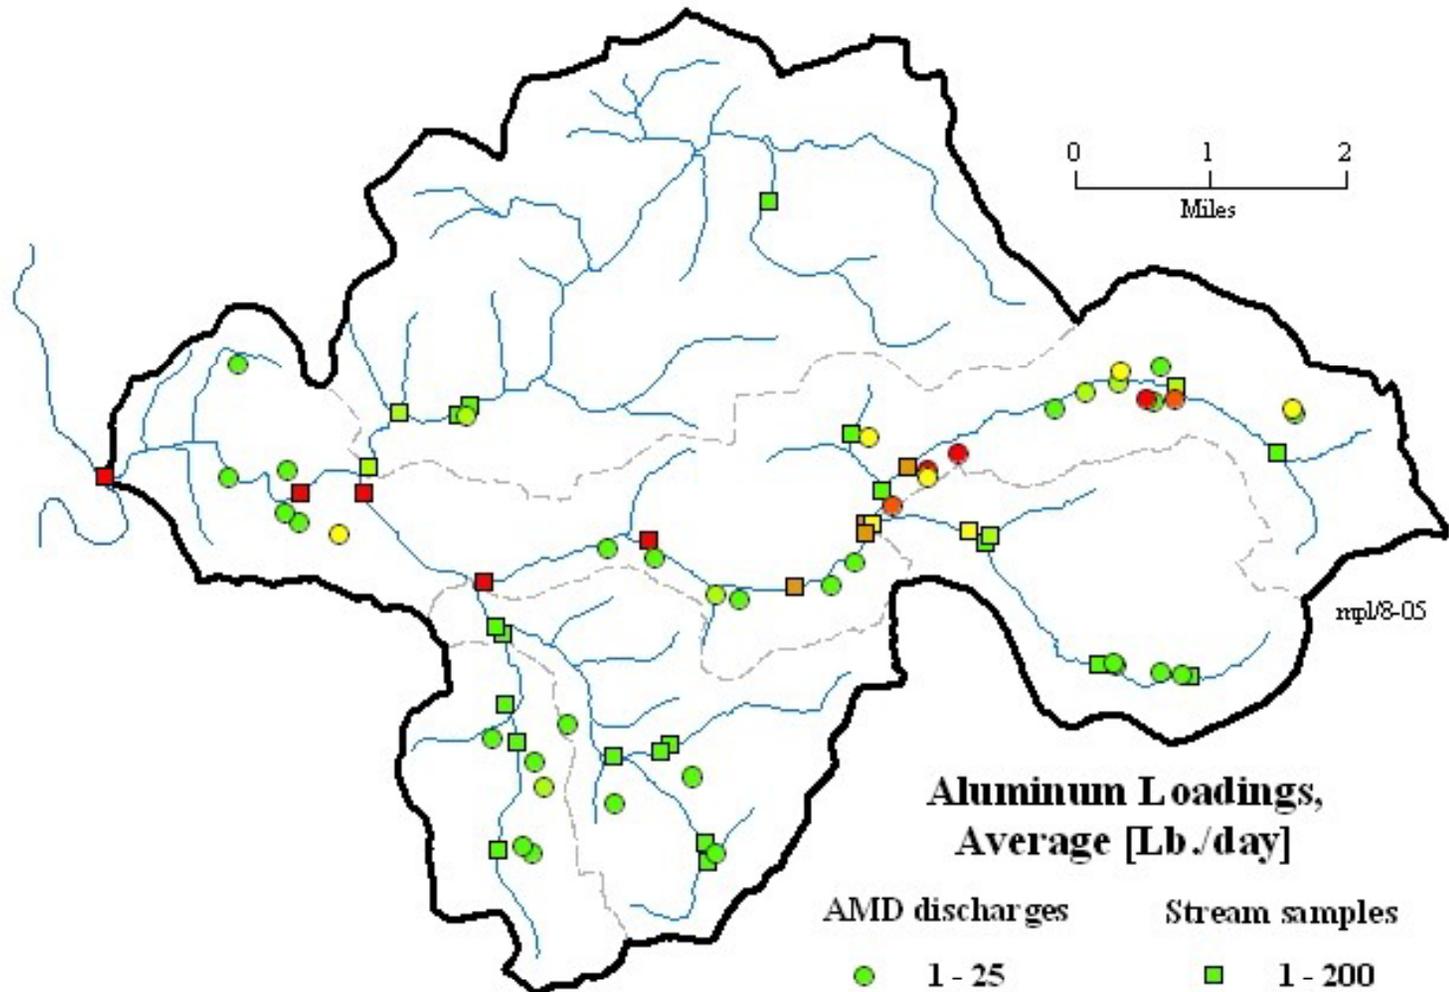
Figure 8. Despite increased volume of flow downstream, Paint Creek never manages to recover from the aluminum released by strip mining in its headwaters, while most of its tributary streams have only modest impact.

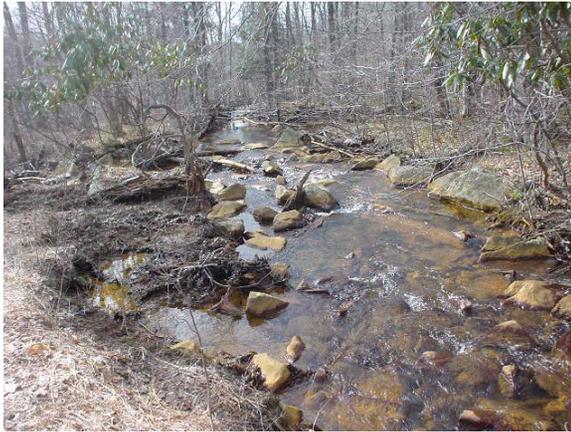
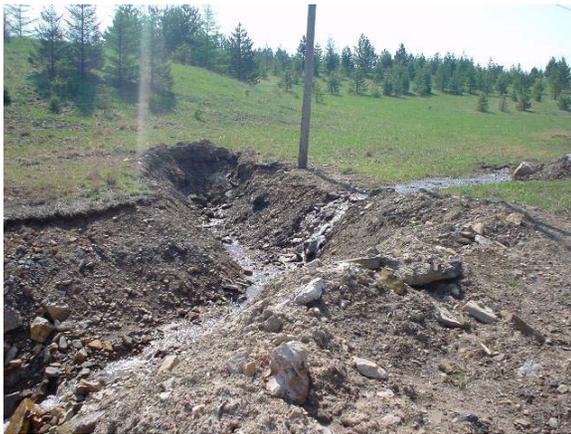
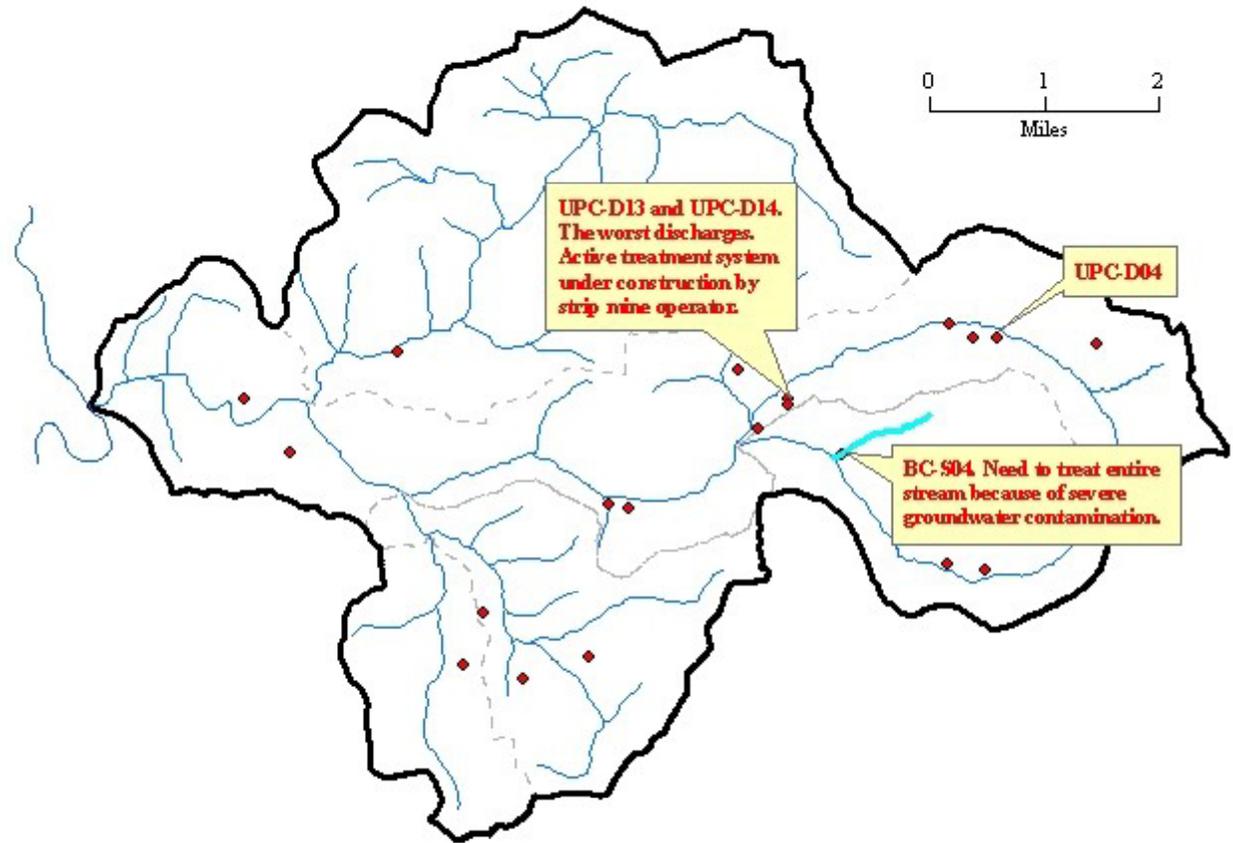
Figure 9. Strip mine operator Cooney Bros. is responsible for the treatment of these sites. These four locations account for roughly 39% of AL, 54% of FE, and 43% of acidity at the mouth of Paint Creek where it joins the Stonycreek River.

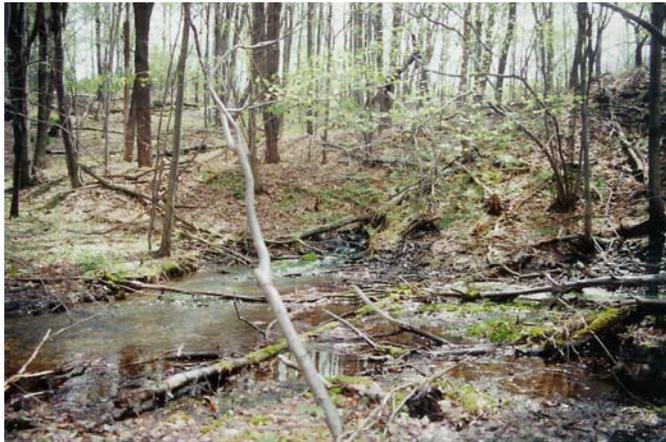
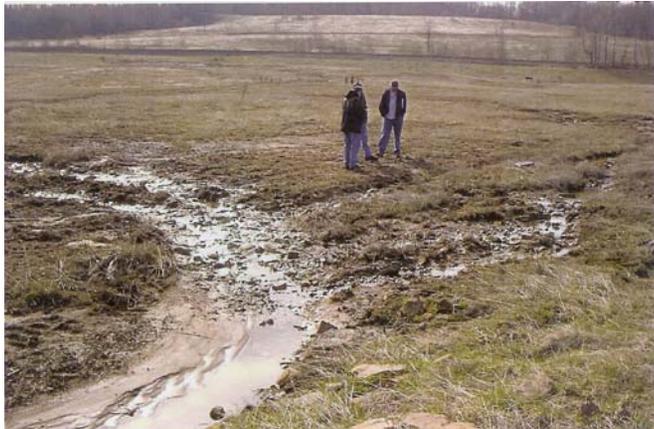
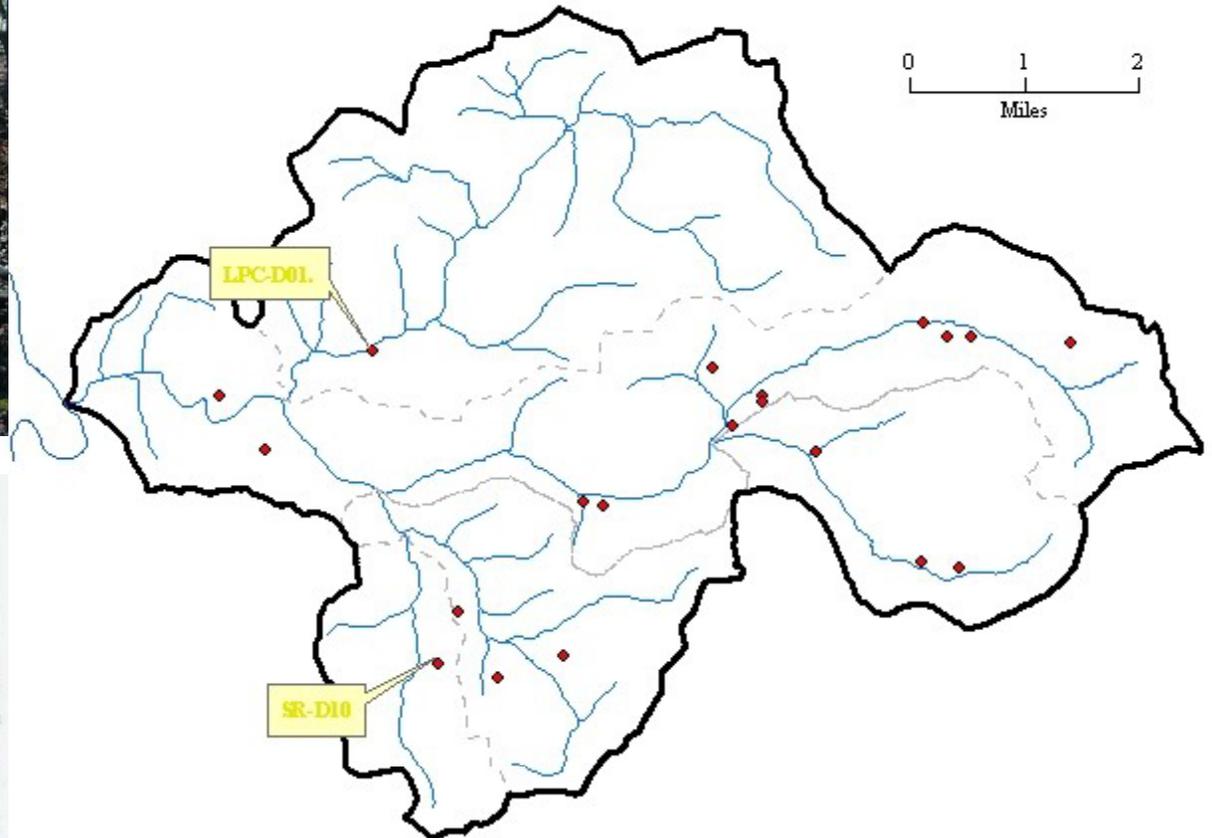
Figure 10. Discharges with passive treatment systems currently being designed. SR-D10 and LPC-D01 only contribute approximately 3% of the acidity loading, 2.5% of the iron loading, and 3% of the aluminum loading entering Paint Creek, but they are the largest contributor of AMD in both the Little Paint and Seese Run sub-watersheds with vast stretches of stream being restored upon treatment.

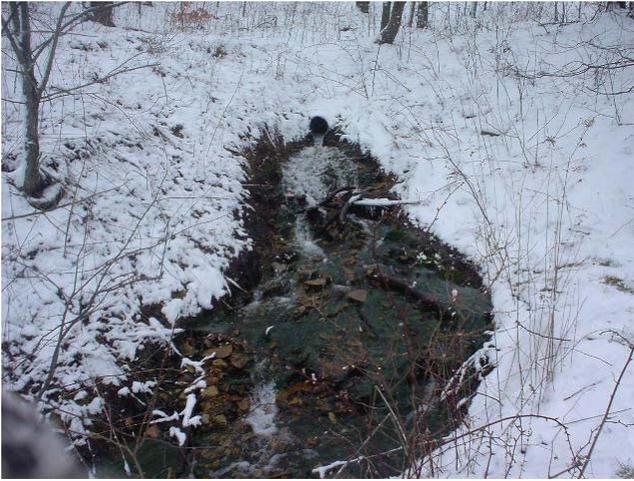
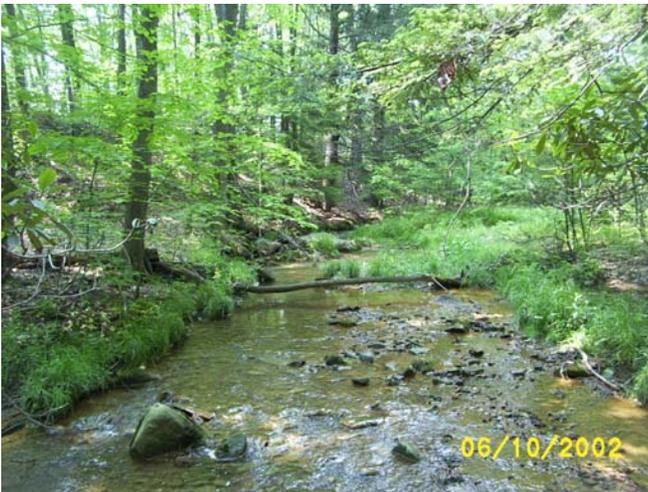
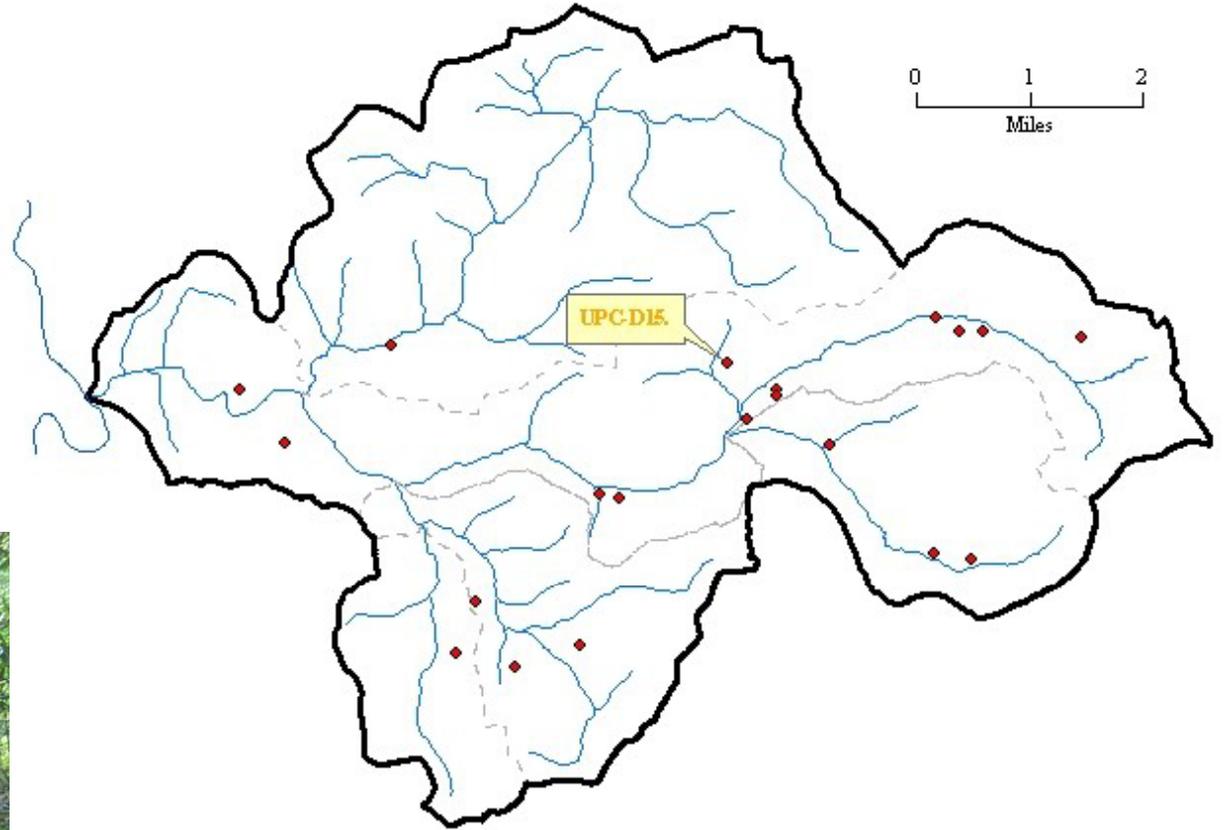
Figure 11. UPC-D15 (Mine 42 Discharge) was denied design funding from PA DEP Growing Greener. It contributes approximately 3.5% of the acidity loading, 4% of the manganese loading and 3% of the aluminum loading into Paint Creek. However, it is the only discharge impacting Picnic Ground Creek, consequently being completely restored upon treatment.

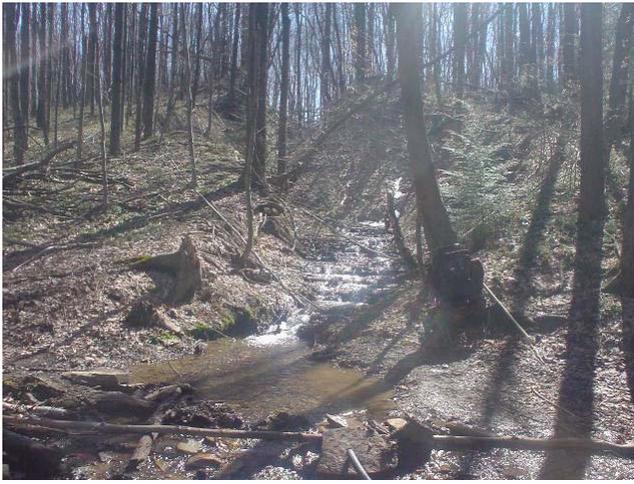
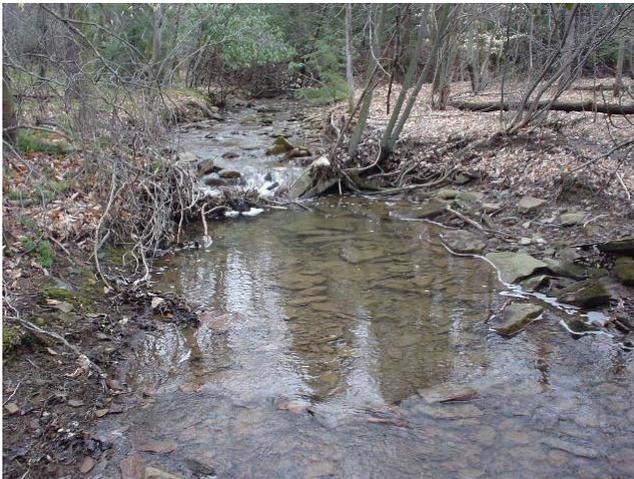
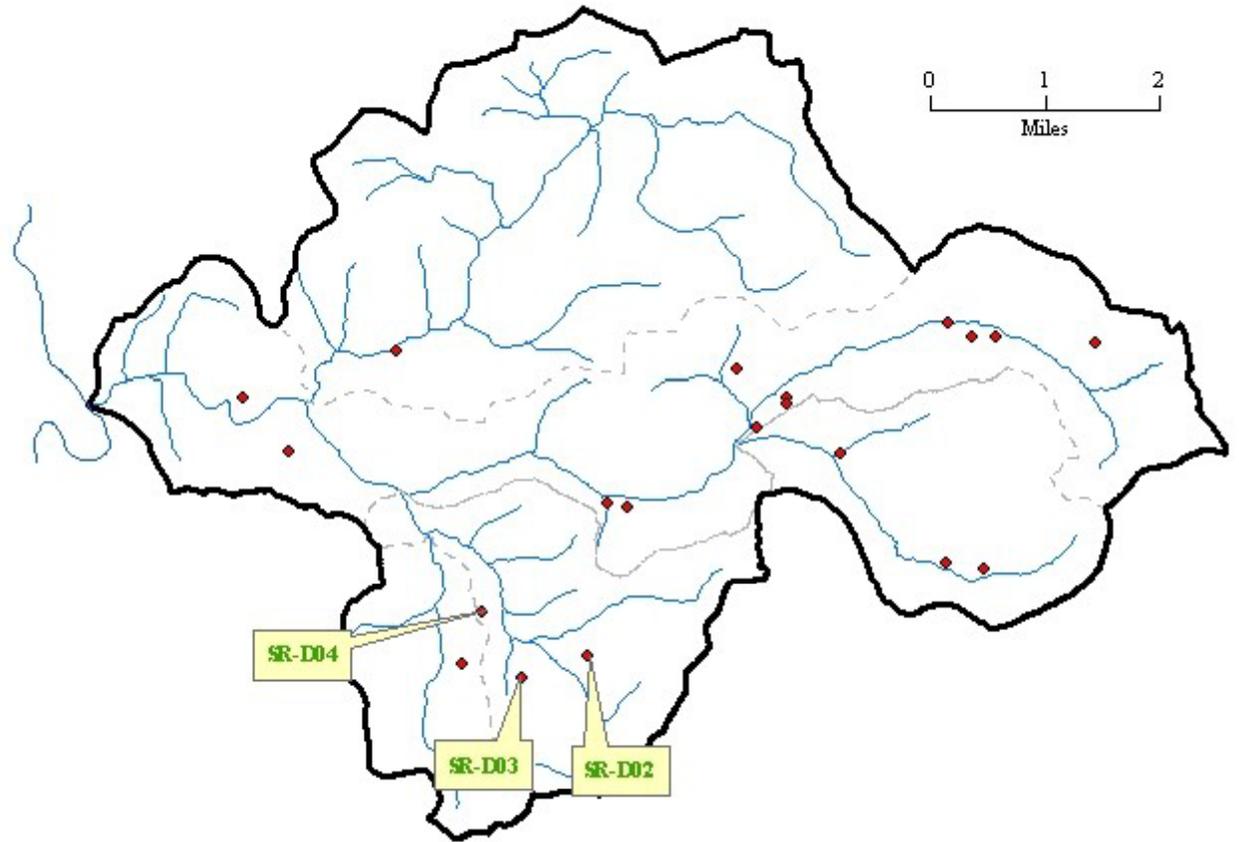
Figure 12. After funding is received for UPC-D15, focus will be turned to the three remaining priority discharges impacting Seese Run. Upon treatment trout will once again likely survive in the Seese Run sub watershed.
